Homespect Inspections
6083 Fairgrove St 269-207-7987
Kalamazoo, MI 49009

555 Anystreet
Anytown, MI

Marginal Summary

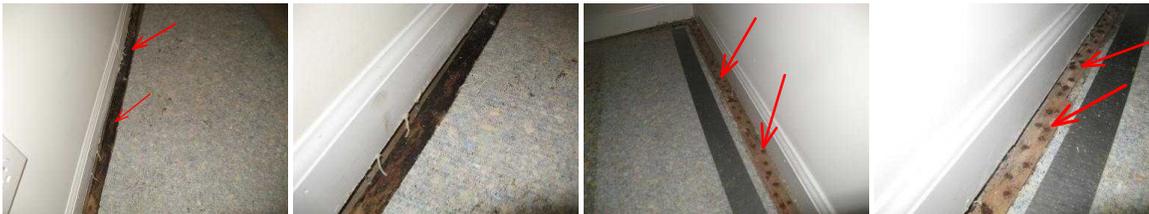
4. **Basement Indications of Past Leaks** Water appeared to have entered the basement in the past. The most likely source of this water would probably be through the basement window. The grade sloped directly toward the window well, which would tend to divert water into the window well. Once the water was in the window well, it could easily enter the basement. There may also be water entry from other locations concealed behind the finished walls.
When I pulled up some of the carpet to examine the wood tack strip, some of the most water damaged tack strip was below the basement window, indicating that as a likely source. I also observed an area of long the rear wall where the tack strip was damaged and rotted. The tack strip was black, indicating severe damage. The rusted metal nails on the tack strip also indicate past water damage. The drywall and wood base board has been recently painted, which could conceal indications of moisture entry behind the drywall or the wood.

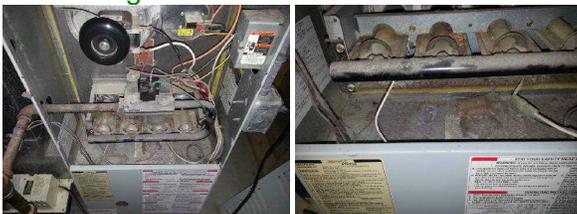
5. **Heating System Heating System Operation:** Maintenance on the furnace has been deferred. The furnace was very dirty and in need of servicing and further inspection by a licensed HVAC contractor. The dryer vented lint into the utility room. Lint covered everything in the utility room, including the furnace, furnace filter, and the interior of the furnace. I recommend that this further checking and evaluation be done PRIOR to closing. Cost estimate given is for further evaluation and minor service only. If problems are found, costs could increase.

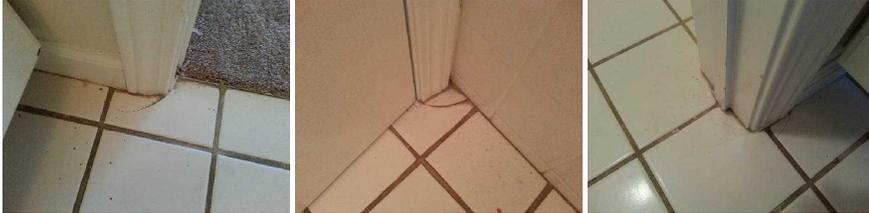
7. Half bath Bathroom Doors: Door needed adjustment
8. 2nd floor master Bathroom Floor: a few cracked floor tiles observed

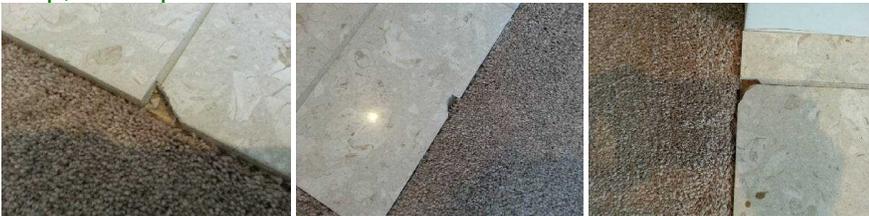
13. Living Room Fireplace Hearth: Some of the marble hearth tiles were chipped on the edges. These could be sharp, and a possible hazard.

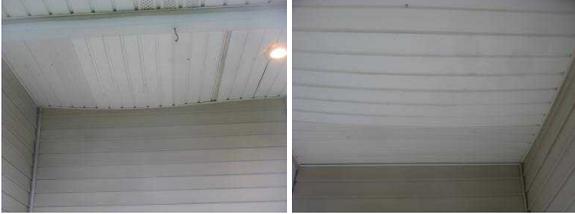
Front porch soffit (continued)

17. Exterior Surface Type: Vinyl siding - The vinyl siding had a number of relatively small holes in it. Some of these were from accessories which had previously been mounted to the siding, while others maybe from hail, BB gun or some other cause.
18. Front porch soffit The sagging soffit observed on front porch was a cosmetic issue only, in my opinion, at the time of my inspection.

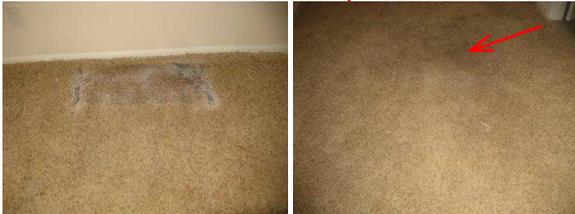
1. **Basement Floor: Carpet, Poured** - Water entry has damaged the carpeting and carpet tack strip. It appeared that the water may have stayed in the carpeting for an extended period, causing deterioration of the carpet, wood tack strip, and the damage to the ceiling tiles observed (ceiling tiles were sagging from excessive moisture). There was also damage to the carpeting from pets. The carpeting, carpet pad, and wood tack strip should be removed and replaced.

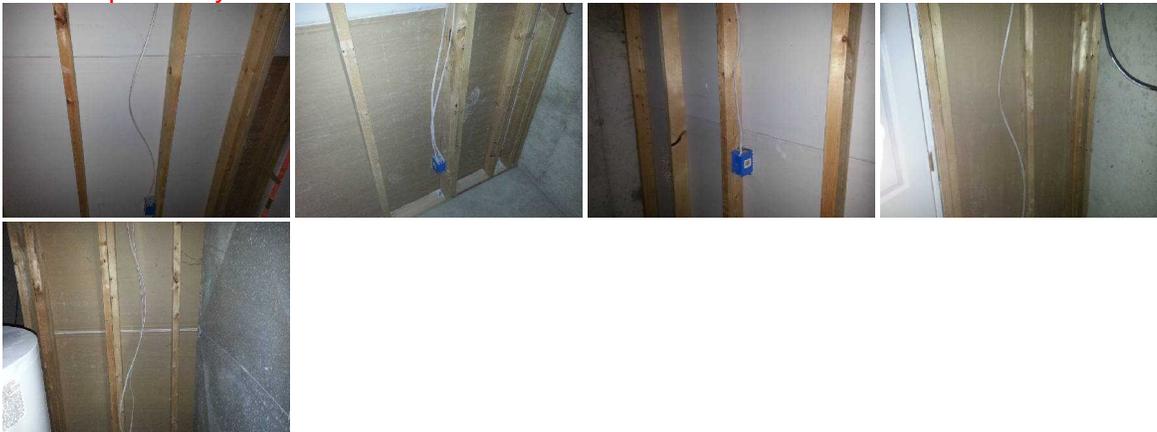
3. **Basement Electrical: 110 VAC, 110 VAC GFCI** -
 1. Improperly secured wiring was observed at the 3 electrical boxes visible in the front water meter area
 2. Improperly secured wiring was observed at 2 receptacles visible in furnace area.
 3. The GFCI receptacle below panel box did not trip when tested.Have repaired by a licensed electrician.

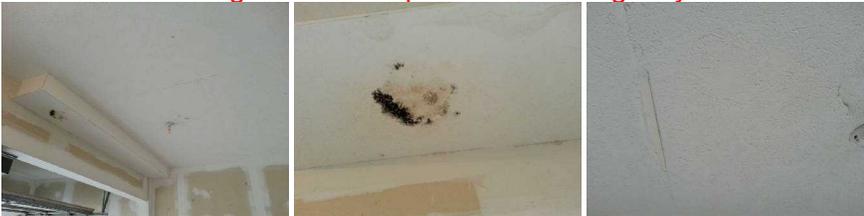
20. Garage Ceiling: The ceiling has been water damaged. The water damage was probably from the bathroom above the garage. The water damaged ceiling tested wet with my moisture meter during my inspection. This indicates that the leakage in the bathroom is probably still active. The leakage will need to be repaired by a licensed plumber before the ceiling can be repaired. All water damaged building materials should be removed and replaced (for example, drywall and fiberglass insulation which may be in the ceiling). The cost estimate given is for repair of the ceiling only.

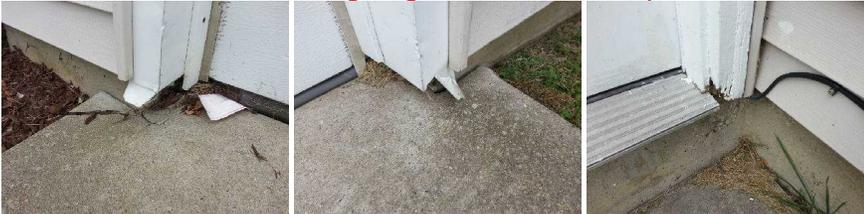
21. Trim: Aluminum, Vinyl, Wood - 1. The sharp aluminum trim around the garage door could be a hazard to people with bare feet, sandals etc.
2. Rotted wood trim at rear garage service door, replace rotted wood trim

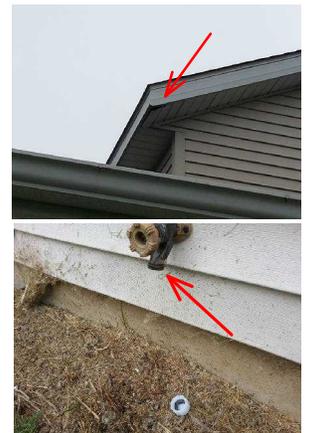
22. Soffits: Aluminum, Vinyl - One piece of loose aluminum soffit observed, on 2nd floor, above garage roof, properly reinstall existing soffit material.

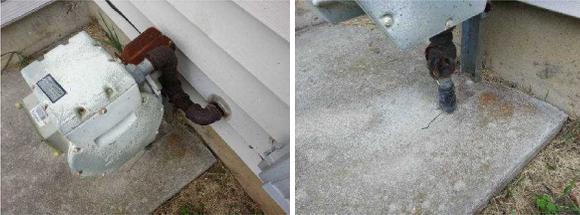
24. **Gas Meter:** I noticed the smell of gas every time I walked near the gas meter. The gas meter was being pulled downward by the settling concrete at the rear service door. The concrete should be carefully removed and then the gas meter and piping should be carefully checked for leaks. This needs correction as it is a hazard. If the concrete is to be re-installed, the pad should be smaller, and should not be poured around the gas piping.

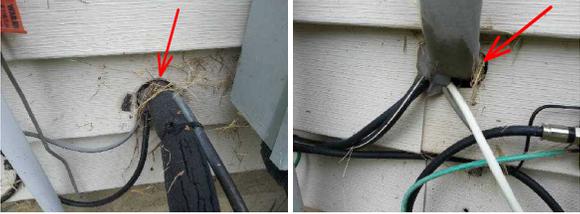
25. **Exterior Sealing** Caulk needed, where air conditioning lines entered the house. Caulk needed, where electric service enters house, to exclude the elements.

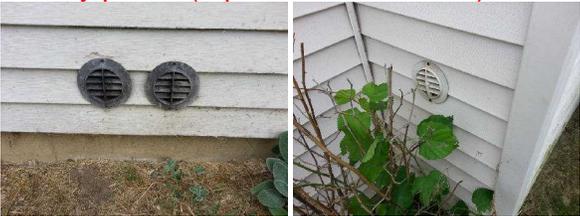
26. **Exterior Vents** The round vent covers used on the lower rear walls were not well sealed and did not have screening installed. Better sealing vent covers should be installed in these locations, to keep out water and possibly pests. (replace 3 vent covers)

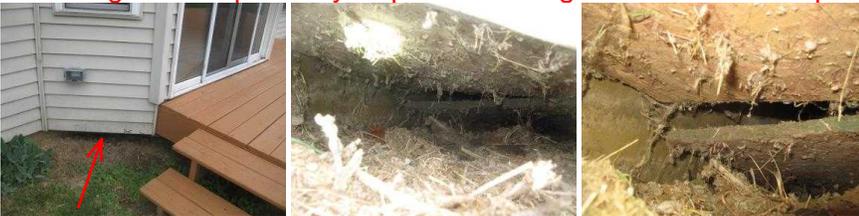
27. **Floor joist covering** The wood covering which was installed to cover the bottom of the rear floor joists (which were cantilevered over the basement wall) has fallen, below the Dinette bay. This needs correction, as the large openings created allow the entry of pests, and lots of unconditioned air. This is a difficult area to access. Correcting this will probably require removing some of the deck planks and some digging with a shovel.

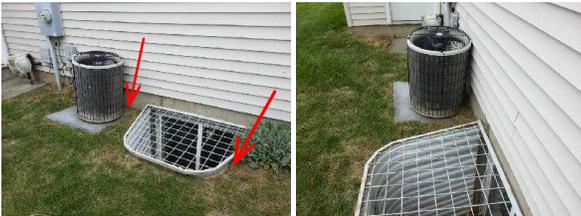
30. Grading: 1. The grade sloped toward window well. Raise the grade near air conditioner to cause water to run away from the house and the window well. Water getting into the water well is a possible source of water entry into the basement.
2.. The grade was low below the rear bay overhang (where the loose cover was, below the dinette area). Note that this area will be difficult to access. Some of the deck planks will need to be removed to get dirt below the rear bay.
Add soil to cause water to run AWAY from the house, instead of toward it.

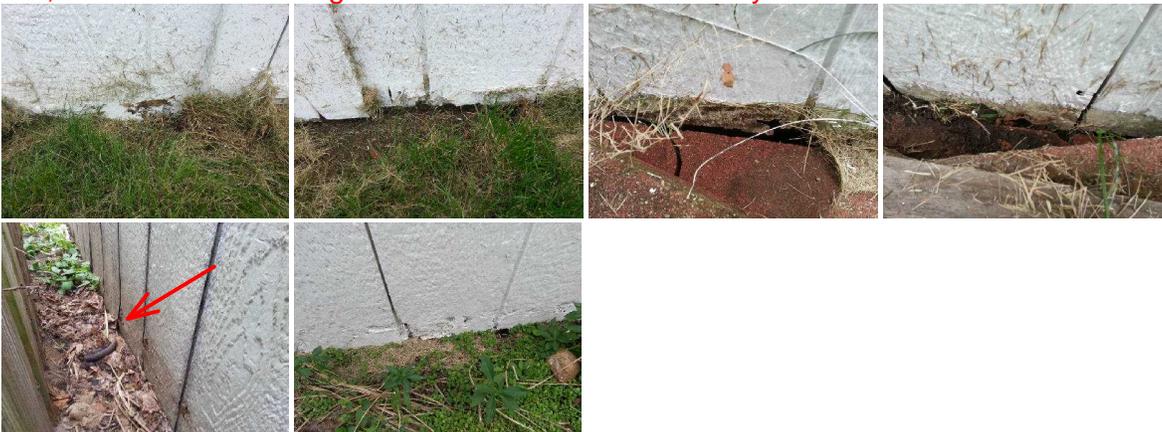
32. Back yard Outbuilding Exterior Surface: Wood - **The lower siding was either covered with landscape blocks, or soil. This has caused the lower siding to decay. The decayed wood appeared to have been recently painted over, but that cannot change the fact that the wood is decayed..**

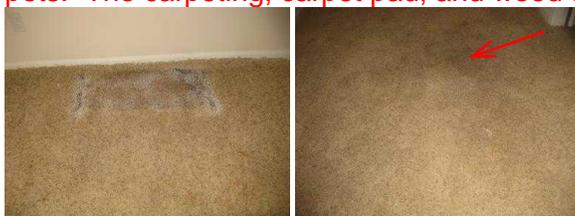
- 1. Marginal Ceiling: Exposed framing, Suspended ceiling - **Most of the ceiling tiles were sagging, probably from excessive moisture from the apparent basement leakage. Indications of the basement leakage were visible on the carpeting.**
- 2. Acceptable Walls: Exposed framing, Concrete, Drywall - Where observed
- 3. Defective Floor: Carpet, Poured - **Water entry has damaged the carpeting and carpet tack strip. It appeared that the water may have stayed in the carpeting for an extended period, causing deterioration of the carpet, wood tack strip, and the damage to the ceiling tiles observed (ceiling tiles were sagging from excessive moisture). There was also damage to the carpeting from pets. The carpeting, carpet pad, and wood tack strip should be removed and replaced.**

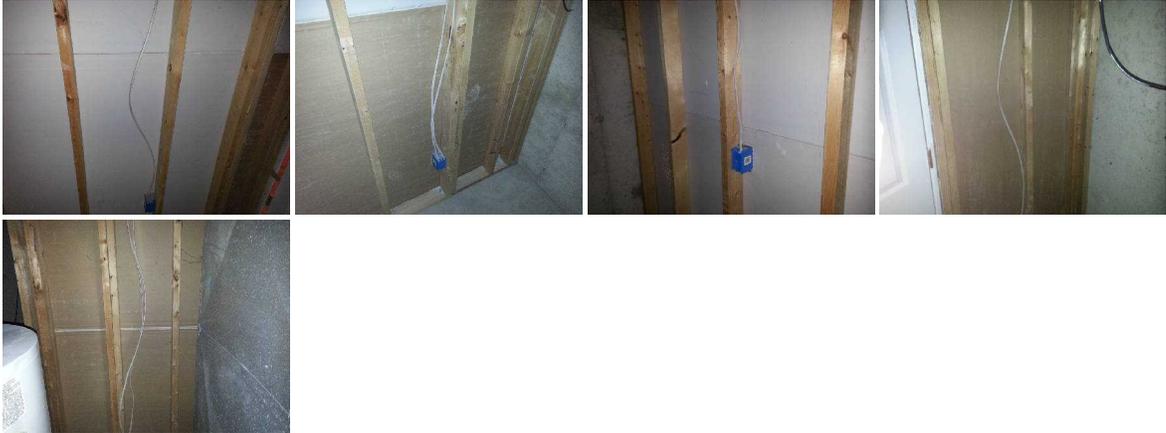
Electrical: (continued)

- 6. Defective Electrical: 110 VAC, 110 VAC GFCI - **1. Improperly secured wiring was observed at the 3 electrical boxes visible in the front water meter area**
2. Improperly secured wiring was observed at 2 receptacles visible in furnace area.
3. The GFCI receptacle below panel box did not trip when tested.
Have repaired by a licensed electrician.

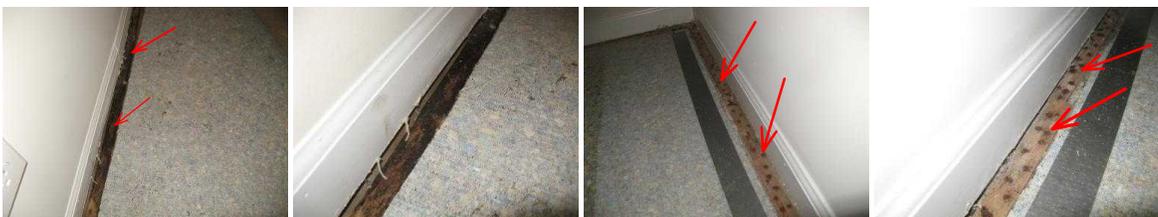
10. Marginal

Indications of Past Leaks Water appeared to have entered the basement in the past. The most likely source of this water would probably be through the basement window. The grade sloped directly toward the window well, which would tend to divert water into the window well. Once the water was in the window well, it could easily enter the basement. There may also be water entry from other locations concealed behind the finished walls. When I pulled up some of the carpet to examine the wood tack strip, some of the most water damaged tack strip was below the basement window, indicating that as a likely source. I also observed an area of long the rear wall where the tack strip was damaged and rotted. The tack strip was black, indicating severe damage. The rusted metal nails on the tack strip also indicate past water damage. The drywall and wood base board has been recently painted, which could conceal indications of moisture entry behind the drywall or the wood.

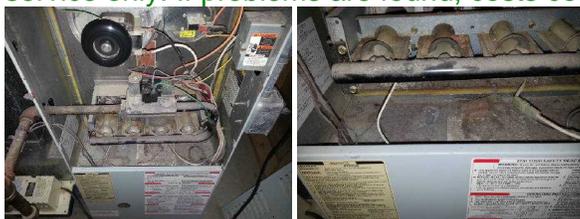
1. Marginal Heating System Operation: Maintenance on the furnace has been deferred. The furnace was very dirty and in need of servicing and further inspection by a licensed HVAC contractor. The dryer vented lint into the utility room. Lint covered everything in the utility room, including the furnace, furnace filter, and the interior of the furnace. I recommend that this further checking and evaluation be done PRIOR to closing. Cost estimate given is for further evaluation and minor service only. If problems are found, costs could increase.

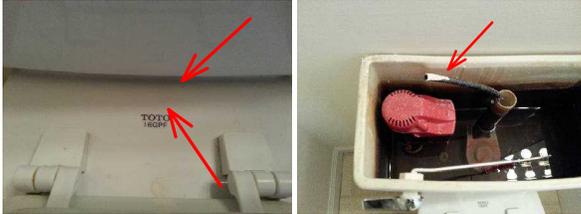
Toilets: (continued)

8. Acceptable Faucets/Traps:
9. Defective Toilets: **1. The toilet leaked at the joint between the bowl and the tank when flushed.
2. The toilet flush valve leaked through broken hose.
I shut the water supply valve off to the toilet to prevent further leakage.
Have repaired by a licensed plumber.**

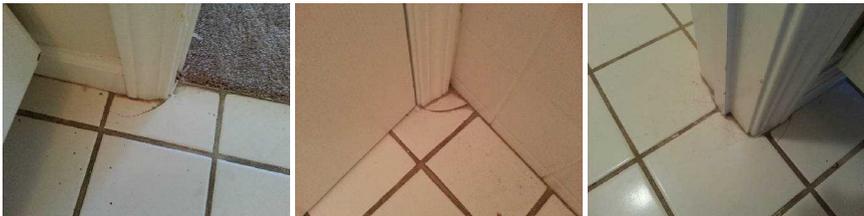
- 2nd floor master Bathroom
- 23. Acceptable Ceiling: Where observed
- 24. Acceptable Walls: Where observed
- 25. Marginal Floor: **a few cracked floor tiles observed**

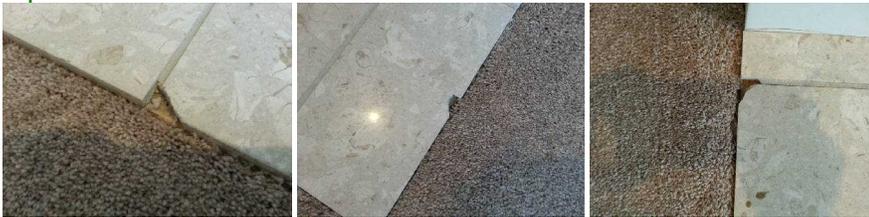
5. Marginal Hearth: **Some of the marble hearth tiles were chipped on the edges. These could be sharp, and a possible hazard.**

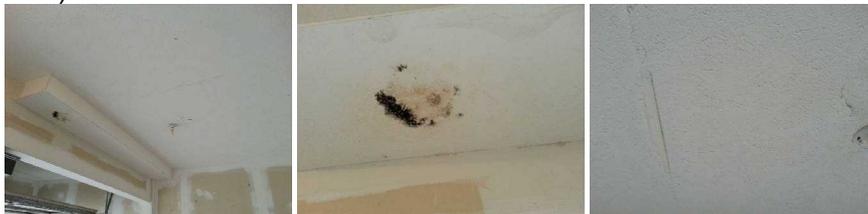
Ceiling: (continued)

There appeared to be a leak or leaks from the master bathroom area, which showed up on the garage ceiling. Further evaluation is needed by a licensed plumber to determine the source of the leak or leaks.

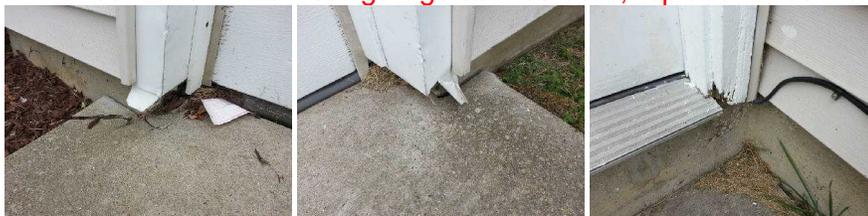
- 2. Defective Trim: Aluminum, Vinyl, Wood -
 - 1. The sharp aluminum trim around the garage door could be a hazard to people with bare feet, sandals etc.
 - 2. Rotted wood trim at rear garage service door, replace rotted wood trim

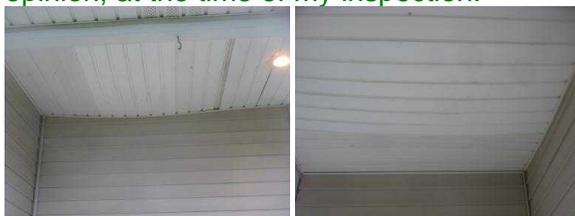
- 5. Marginal Front porch soffit The sagging soffit observed on front porch was a cosmetic issue only, in my opinion, at the time of my inspection.

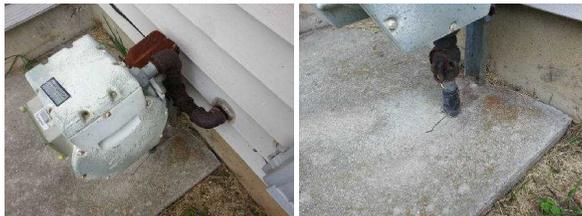
13. Defective

Gas Meter: I noticed the smell of gas every time I walked near the gas meter. The gas meter was being pulled downward by the settling concrete at the rear service door. The concrete should be carefully removed and then the gas meter and piping should be carefully checked for leaks. This needs correction as it is a hazard. If the concrete is to be re-installed, the pad should be smaller, and should not be poured around the gas piping.

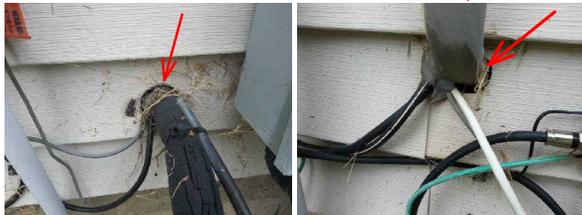
14. Defective

Exterior Sealing Caulk needed, where air conditioning lines entered the house. Caulk needed, where electric service enters house, to exclude the elements.

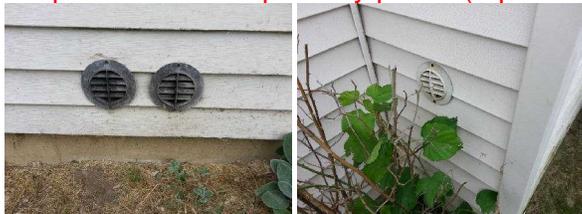
15. Defective

Exterior Vents The round vent covers used on the lower rear walls were not well sealed and did not have screening installed. Better sealing vent covers should be installed in these locations, to keep out water and possibly pests. (replace 3 vent covers)

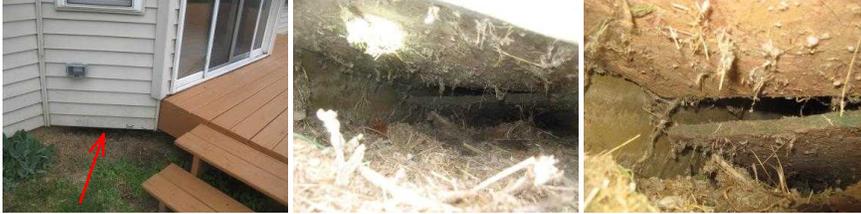
Floor joist covering (continued)

Floor joist covering The wood covering which was installed to cover the bottom of the rear floor joists (which were cantilevered over the basement wall) has fallen, below the Dinette bay. This needs correction, as the large openings created allow the entry of pests, and lots of unconditioned air. This is a difficult area to access. Correcting this will probably require removing some of the deck planks and some digging with a shovel.

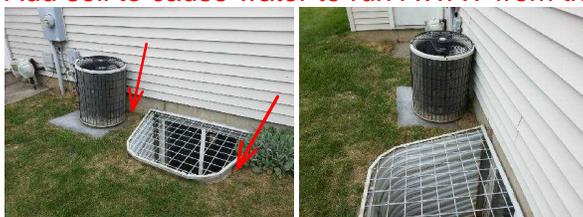
- 3. Acceptable Steps/Stoops: Concrete, Wood
- 4. Acceptable Deck:
- 5. Defective Grading: **1. The grade sloped toward window well. Raise the grade near air conditioner to cause water to run away from the house and the window well. Water getting into the water well is a possible source of water entry into the basement.**
2.. The grade was low below the rear bay overhang (where the loose cover was, below the dinette area). Note that this area will be difficult to access. Some of the deck planks will need to be removed to get dirt below the rear bay.
Add soil to cause water to run AWAY from the house, instead of toward it.

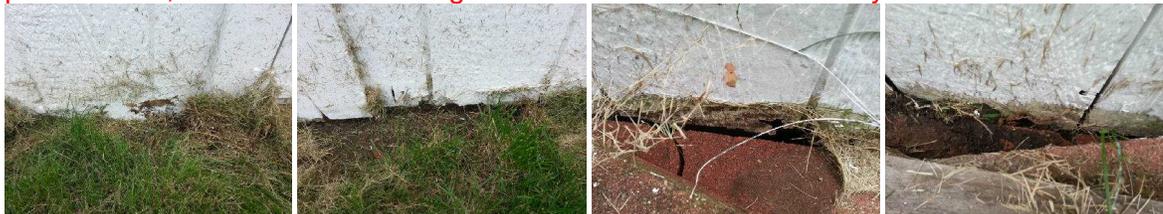
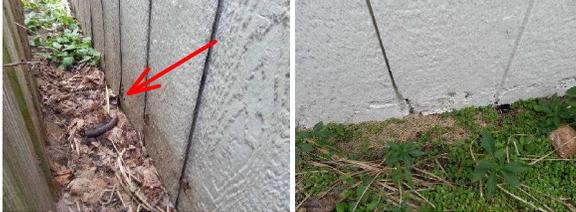
Exterior Surface: (continued)

- 1. Defective Exterior Surface: Wood - **The lower siding was either covered with landscape blocks, or soil. This has caused the lower siding to decay. The decayed wood appeared to have been recently painted over, but that cannot change the fact that the wood is decayed..**
